Mapping Sinkhole Collapse in Public Roadway

Our company was contracted to perform a geophysical investigation to define the boundaries of a sinkhole that had opened near a retention drainage system along a major roadway in Palm Harbor, FL. NSN performed this initial geophysical investigation using our Supersting R8 resistivity/IP unit produced by Advanced Geosciences, Inc. A series of 5 transects were performed over and parallel to the sinkhole extending from either side of the feature. This investigation ultimately led to a comprehensive Cone Penetrometer Testing program which validated anomalies discovered during the geophysical phase of this project. This emergency project was completed at the request of Pinellas County Department of Public Works and with the cooperation of the Florida Department of Transportation.

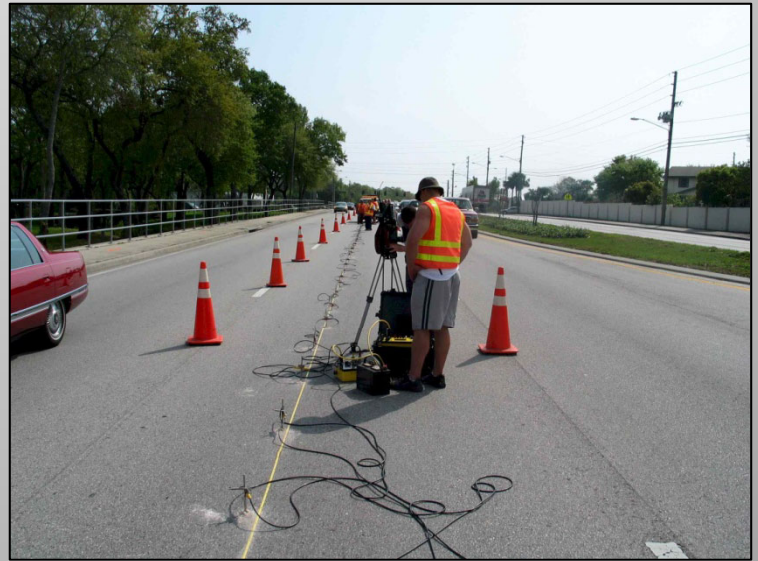
MER Transect in Roadway

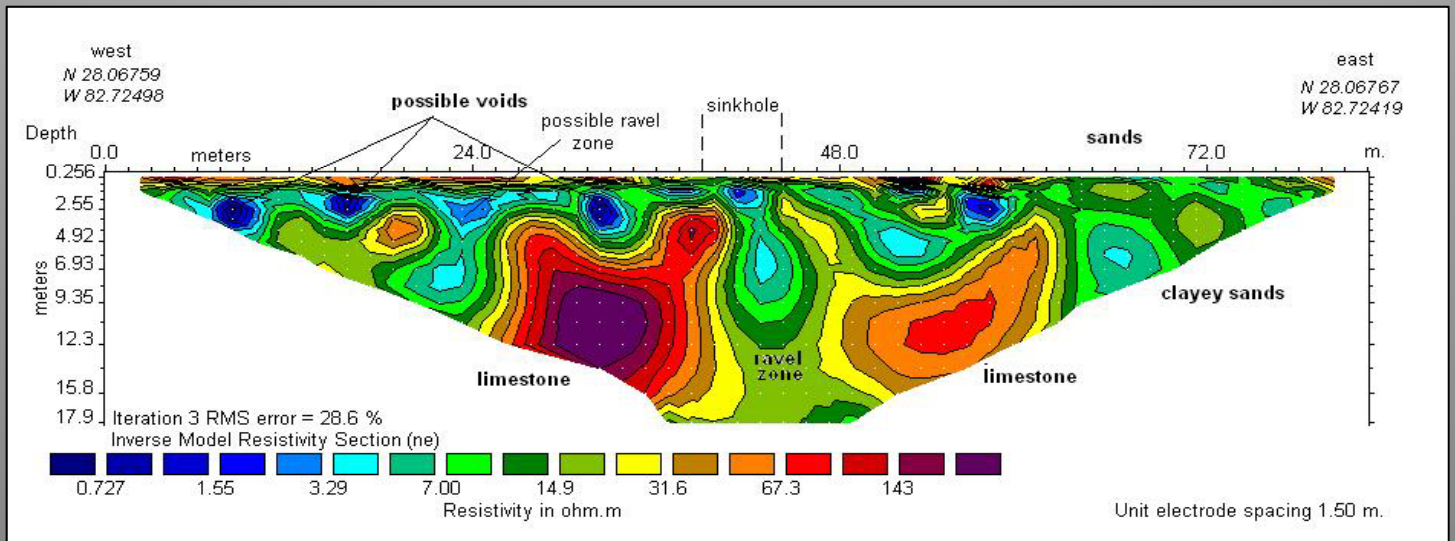
MER Transect Inverted Resistivity Profile
